Quest Engineering & Failure Analysis, Inc.
www.quest-engineering.com

Re: FR26 Report

File: Bryson Accident
Quest No: 10519

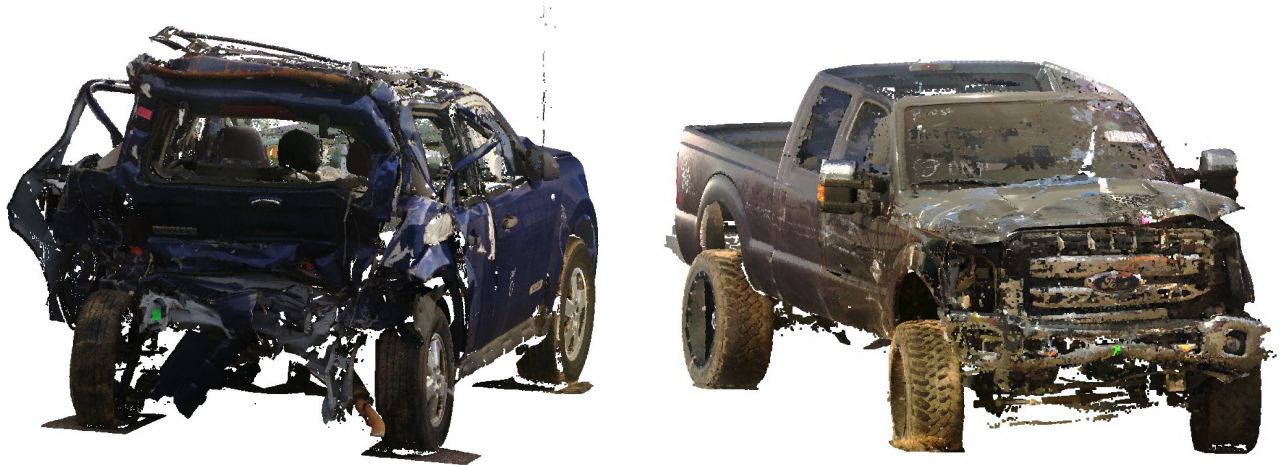
Figure 2: Brightly colored tape visible on the point cloud models

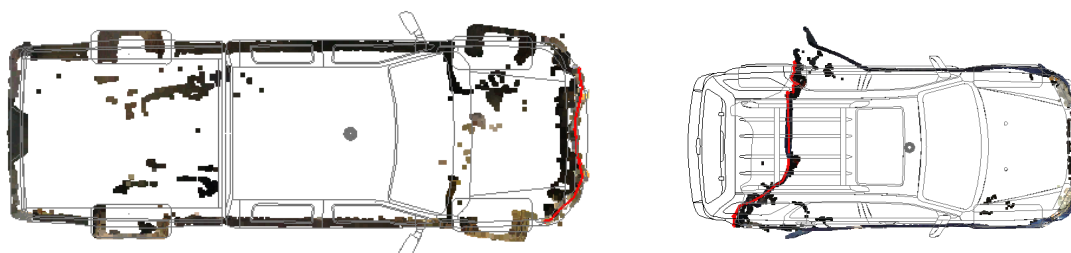
The damage profile was placed over an undamaged vehicle drawing, showing the change in the vehicle's shape (*Figure 4*). This was used to determine the amount of crush on the vehicle. In order to compare the damaged vehicle to an undamaged vehicle, an exemplar Ford F250 was inspected and scanned. The F250 inspected was a stock, unaltered, 2015 Ford F250 Super Duty Crew Cab 4x4 Pickup with LT275/70R18 tires. The exemplar was verified by using the Vehicle Identification Number (VIN). An exemplar Ford Escape, which was also stock and unaltered, was also inspected and scanned. The exemplar Escape was also scanned with an exemplar Safety 1st child seat, positioned in the rear left seat. The exemplar for the Escape was a 2010 Ford Escape 4x2 with the same size tires as the accident vehicle (235/70R16). The Escape exemplar was also verified using the VIN.

Figure 4: Crush lines from scan cross section

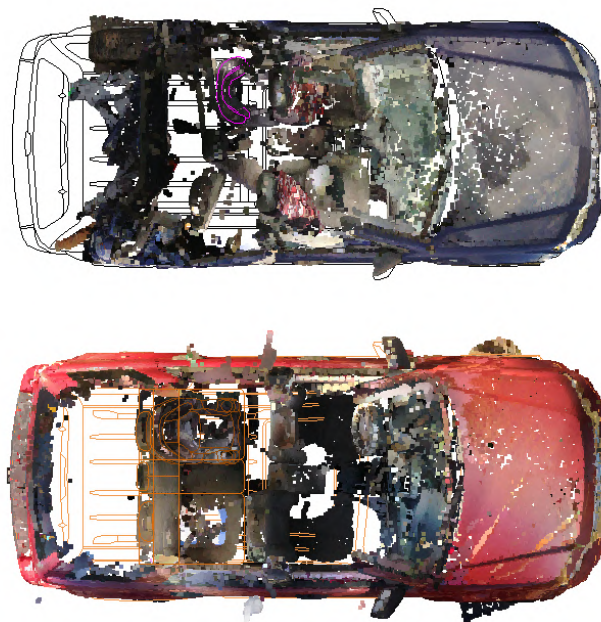
The rear seat of the Escape had been displaced forward significantly. To measure the change in forward distance that the seat had been displaced, the roofs of the subject Escape and the Escape exemplar scans were cropped, revealing the interior of the vehicles. Because the rear seat moved forward, the child seat also moved forward. The exemplar car seat was scanned in the exemplar Escape; therefore, it was visible in the cropped scan. The accident car seat no longer fit in the subject Escape. Using a 3D editing software, CloudCompare, the exemplar car seat was placed in the scan of the accident Escape based on DOA photos. This model was imported into AutoCAD and the roof was cropped, revealing the difference in the forward distance of the child seat. The movement of the head rest area and the bottom of the seat were compared (*Figure 5*).

Figure 5: Rear seat and child seat change in position

- The Escape felt a maximum of near 23.6 g's.
- The left rear occupant position had approximately 1.5 feet of forward static shift and the dynamic shift of the head rest area of the child's seat was approximately 2 feet.

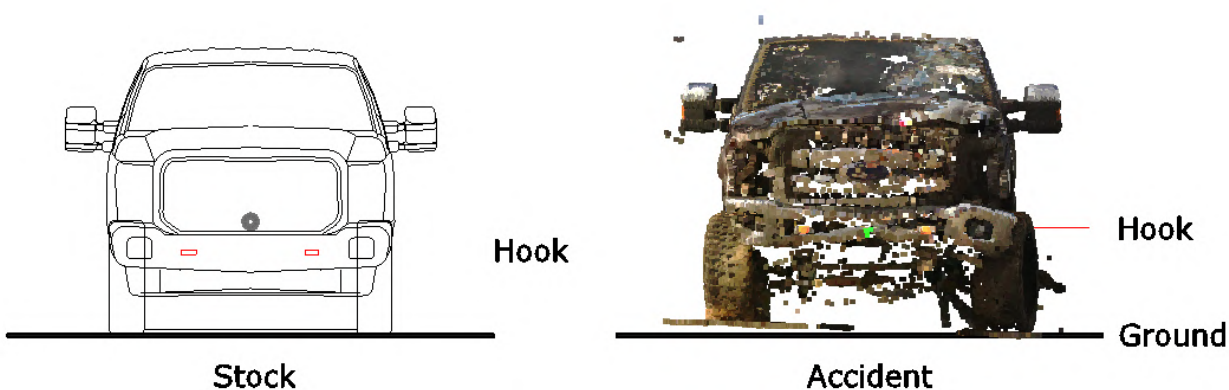
The difference in height of the F250 was determined by using side views of the F250 in AutoCAD. The scan of the exemplar (stock) F250 was drawn and the subject F250 was drawn. This revealed the height difference between the stock and lifted F250 (*Figure 6*). This was also verified by using measurements of the subject F250 and comparing against the exemplar F250.

Figure 6: Stock F250 comparison to Accident F250

- The F250 was effectively lifted over 6 inches.
- In the subject accident the F250 bumper penetrated to beyond the original location of the child seat pushing the child seat's head rest area (Safety 1st logo) forward by over 18 inches to a post-crash rest location of 1.1 feet from the rear of the driver's static seat back location.
- Dynamic analysis and damage matching reveal that during the crash the F250 bumper penetrated 4.36 feet into the rear hatch trunk and rear seat position areas, pushing the child seat's head rest area (Safety 1st logo) forward over 2 feet to a during-crash location only about 6 inches from the driver's static seat back location (top of the seat).
- Had the lift kit not been installed, the stock F250 would have interacted more directly with the stronger structural components of the Escape rear as opposed to the Escape hatch and pillars.

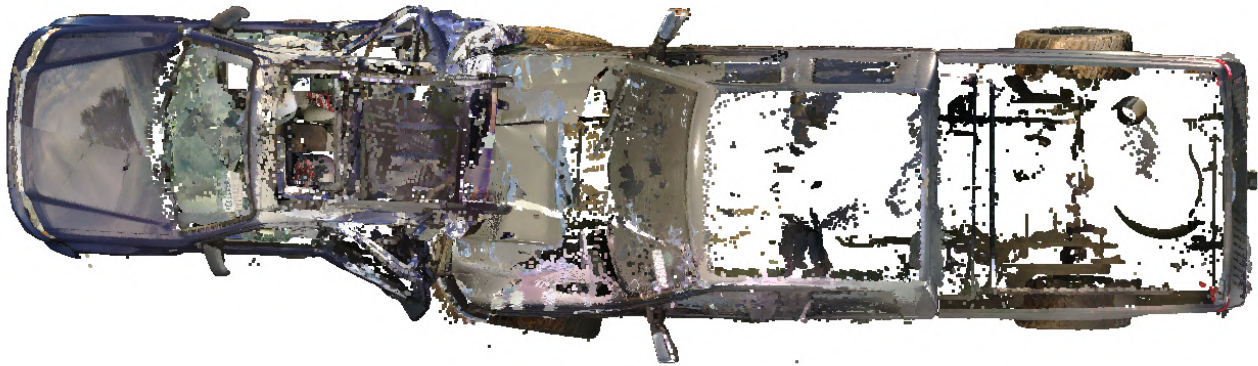
The point clouds were also used in CloudCompare. In CloudCompare, 3D models (including point clouds) can be viewed, cropped, rotated, and translated. The match points of the vehicles were linked together in 3D space using CloudCompare. This was simplified due to the bright colored tape that was placed on the vehicle at the inspection which showed up on the scan. Primarily, four match points were needed to link the two vehicles together. The hood of the F250 displayed two small rectangular intrusions that were 28 inches apart. The Escape had two protruding hinges that held the top of the rear windshield in place that were also 28 inches apart. In addition, the hinges on the

Escape displayed contact evidence. Based on the measurements, shape, and size of the markings, revealing that this was a match point. In CloudCompare, the two vehicles were matched together based on these two marks (*Figure 7*). Another match point was where the tow hooks of the F250 impacted the rear hatch of the Escape. The F250 has two tow hooks that are located near the center of the bumper. The Escape had a hole immediately to the left side of the bottom of the rear hatch and another hole that was near the right side of the centerline of the vehicle. The analysis revealed that the F250 tow hooks matched the holes of the Escape. Additional match points increased the certainty of the model.

Figure 7: Maximum Engagement modeled in 3D
